different materials, single goal

The article presents technical-clinical procedures adopted for a prosthetic solution that conforms with nature, using coordinated clinical procedures and many technical procedures carried out with the aid of different metal-free materials for the fabrication of prosthetic restorations, specifically Zirconium Dioxide (Zirconia) and Lithium Disilicate.

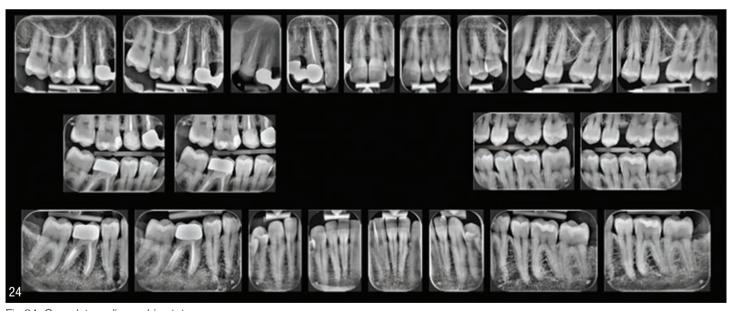
Fig 24: Complete radiographic status

The radiographic examination reveals inadequate endodontic treatment of 15, 14, 12, 46. Note the presence of a ceramic metal bridge from 14-12 (probably made due to the agenesis of the lateral incisor and the ectopic position of the canine in sextant 1).

There is a crown on tooth 46 with over-contoured prosthetic margins. The absence of 12 and the position highlight ectopic tooth 13.
